WL-TR-95-4108

**HIGH TEMPERATURES COATINGS
FOR TITANIUM ALUMINIDES**

**J. C. Schaeffer
R. L. McCarron**

**GENERAL ELECTRIC COMPANY - AIRCRAFT ENGINES
ENGINEERING MATERIALS TECHNOLOGY LABORATORIES
CINCINNATI, OHIO 45215-6301**

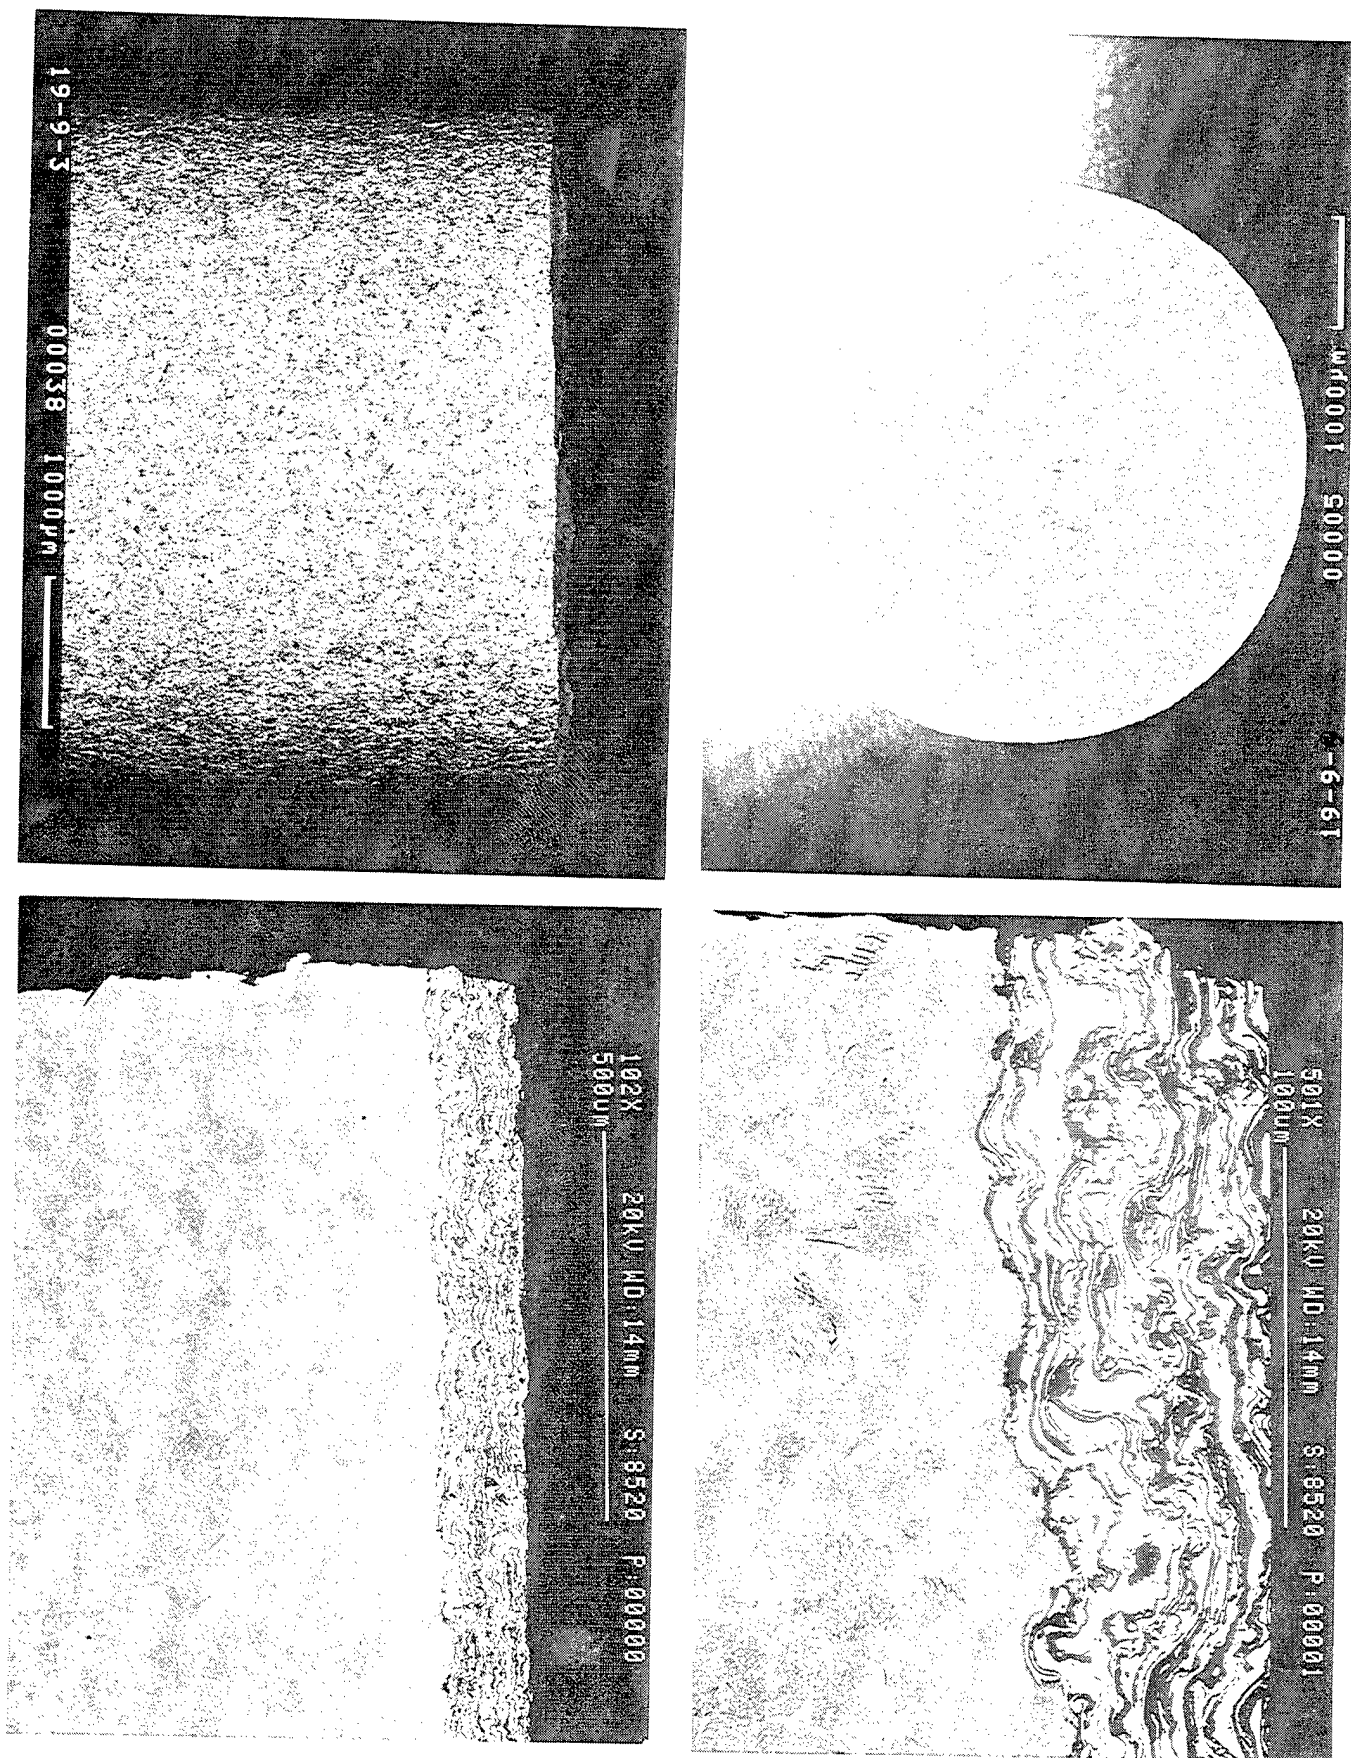
Figure 273. Surface and cross section of a cermet coated gamma sample that failed during the first TMF cycle.

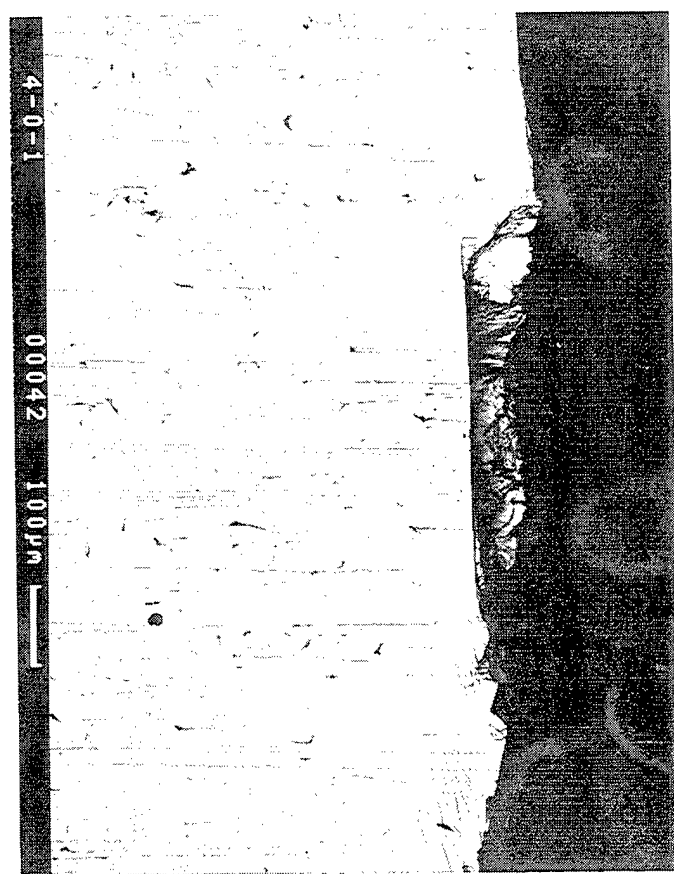
Figure 274. Fractography of an uncoated alpha-2 sample that failed after 1508 TMF cycles.

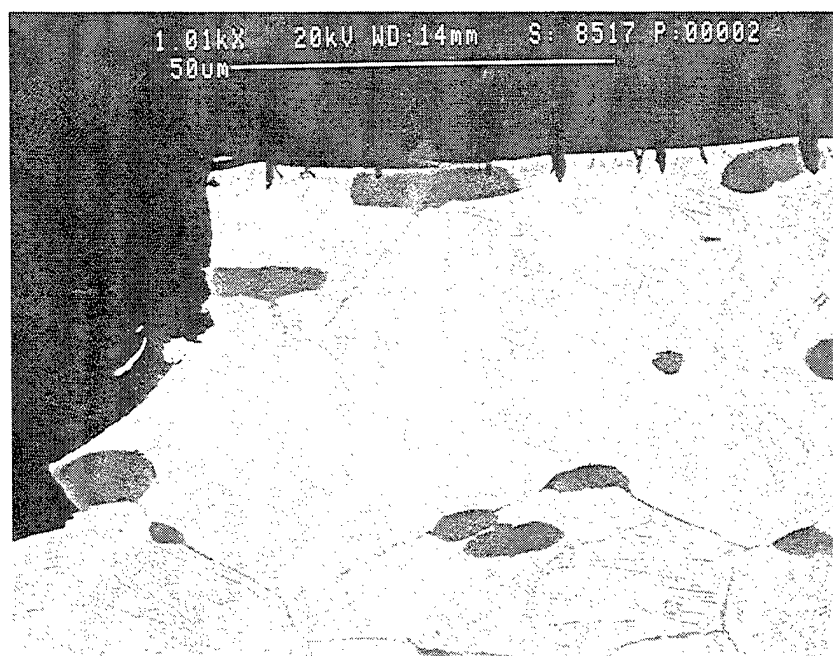
Figure 275. Cross section of the uncoated alpha-2 sample that failed after 1508 TMF cycles.

Figure 275 shows cross-sections of the same sample. An array of secondary cracks observed was at the surface with a depth of ~5 μ m and a spacing of ~15 μ m. The cracking appears independent of the phases in the alpha-2 but, backscattered imaging at high magnification shows a

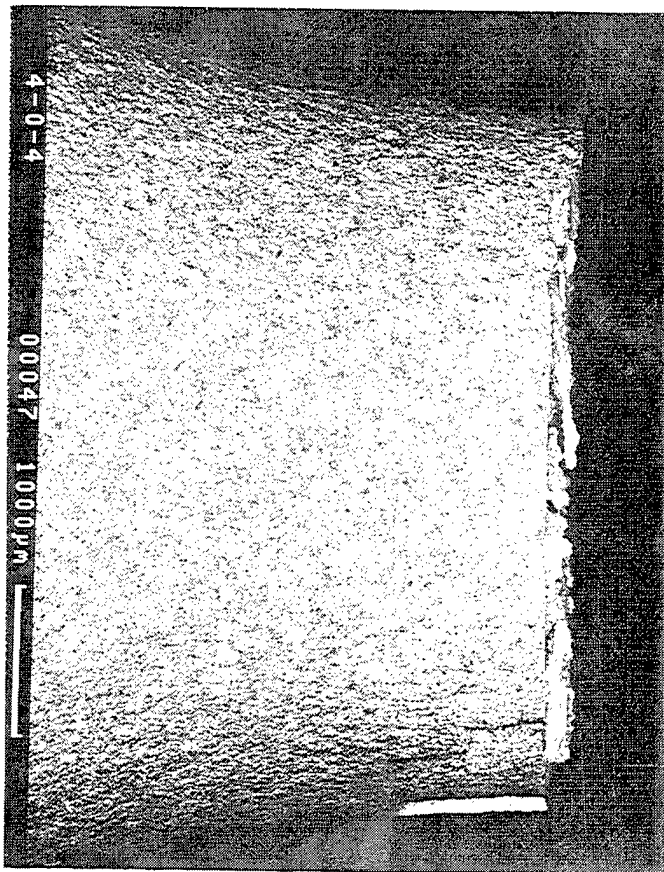
Figure 276. Fractography of a cermet coated alpha-2 sample that failed after 952 TMF cycles.
